robustdetails[®]

What is a Robust Detail?

Surveillance findings

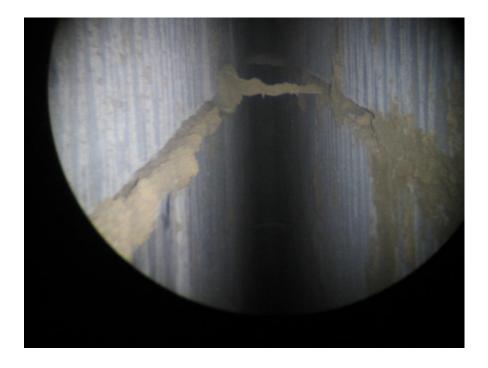
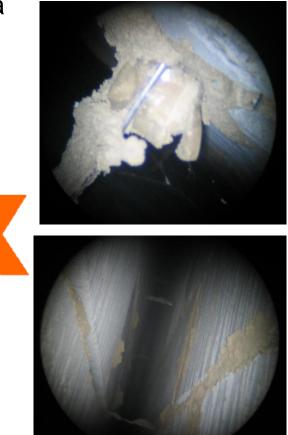
Mortar bridging or incorrect wall ties were suspected so, with the assistance of the builder a borescope was used to view the cavity...

Having cleaned the cavity (accessing from the end of the wall), re-tests revealed a considerable improvement.

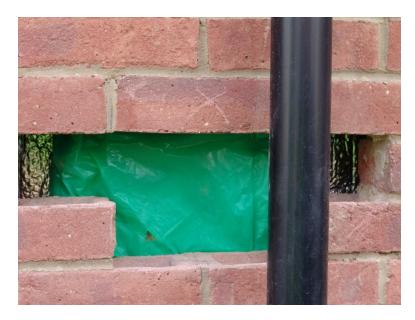
Airborne D _{nT,w} +C _{tr}
Test 1 – ground floor	46
Test 2 – first floor	43
Test 3 - first floor – repeat test	44
Test 4 - ground floor – test following remedial work (PCT)	50
Test 5 - first floor – test following remedial work (PCT)	48

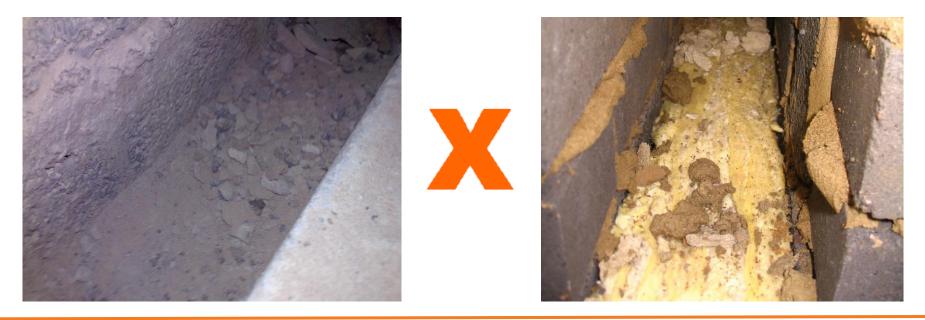
Mortar bridging was suspected but the cavity insulation meant that use of a borescope to view the cavity was not viable.

The builder chose to remove the plaster and sections of blockwork, discovering that mortar/debris had collected on the insulation and ties.

Having cleaned the cavity and re-built the wall, re-tests revealed a considerable improvement (particularly in terms of low frequency).

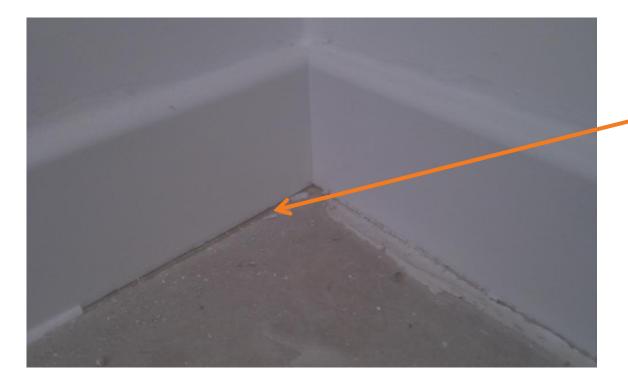
Investigations identified that the 'weakness' was associated with the perimeter detailing of the floating screed finish.

Removing the mastic seal at the base of the skirtings revealed that the skirting was in contact with the screed finish.

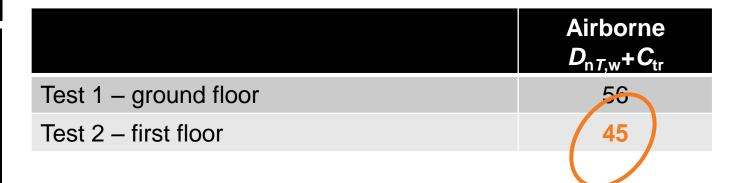
A surveillance visit to test separating walls identified an issue with airborne performance at first floor level:

The sound transmission seemed to be passing over the separating wall, via the roof void.

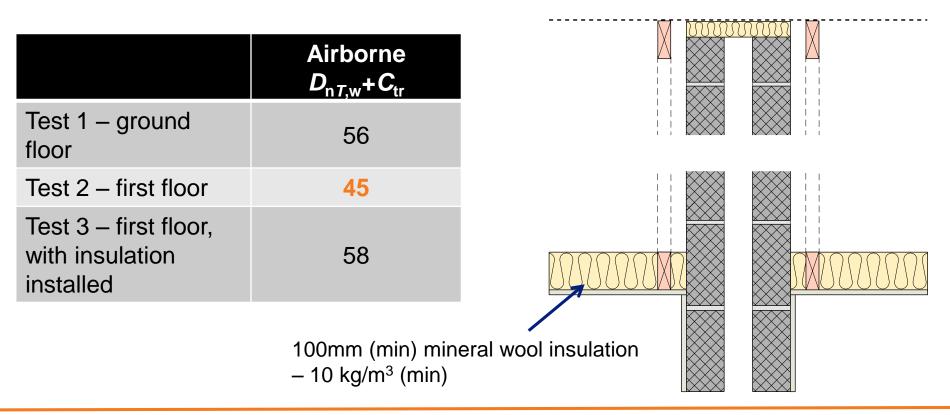
A check in the roof void revealed that...

... the loft insulation had not been installed

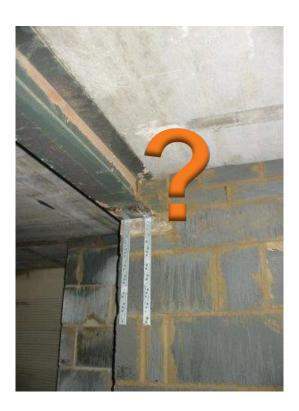
Guidance is provided in Appendix A1 of the Robust Details Handbook regarding the use of steel beams to support concrete floors.

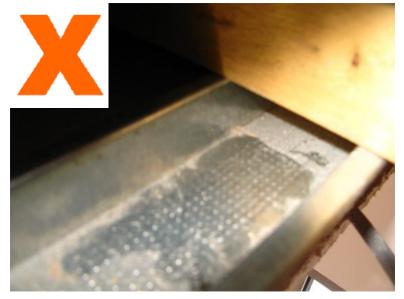
Tapping the ceiling from beneath revealed areas that sounded hollow and other areas that sounded solid.

The builder assisted in the investigations by opening the ceiling, which revealed...

Non-resilient bars used to support the ceiling boards, causing a rigid connection.

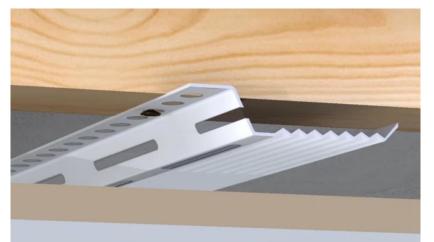
Timber floors - resilient bars

Ensure ceiling treatment is correct and take care not to compromise the resilient bars.

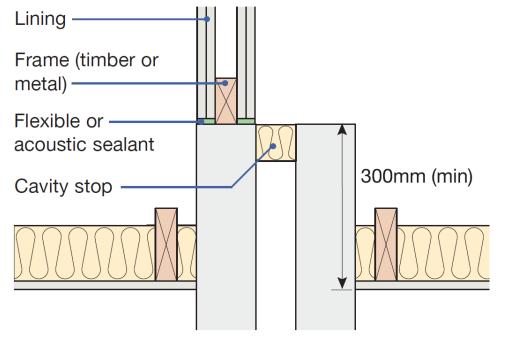
A review of the drawings revealed that a spandrel panel had been used in the roof void, immediately above the second floor rooms.

The drawings indicated that the correct detail, as shown in Appendix A1 of the Robust Details Handbook, was intended.

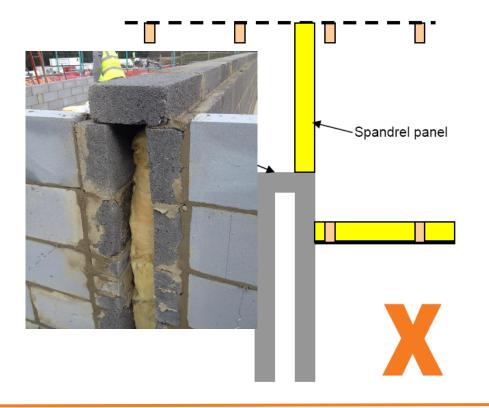
A check in the roof void revealed that a spandrel panel had been used but...

...the cavity wall had been closed at the top with blocks laid flat!

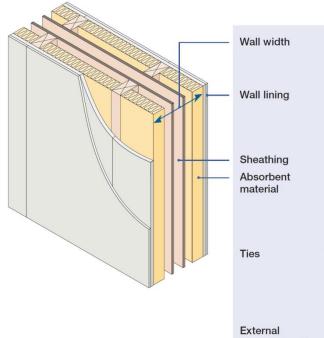
The registrations were for the use of the E-WT-2 timber separating wall, in a timber frame block of flats.

With sheathing board Twin timber frames

240mm (min) between inner faces of wall linings. 50mm (min) gap between wall panels

- 2 or more layers of gypsum-based board (total nominal mass per unit area 22 kg/m²), both sides - all joints staggered

60mm (min) mineral wool batts or quilt (density 10 – 60 kg/m³) both sides. Material may be unfaced, paper faced or wirereinforced

Ties between frames not more than 40mm x 3mm, at 1200mm (min) centres horizontally, one row of ties per storey height vertically

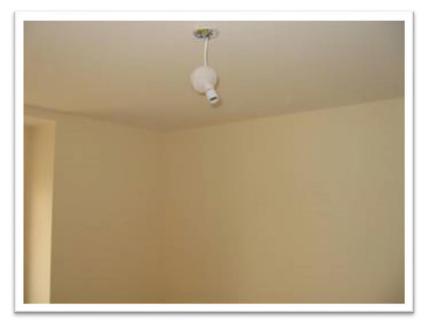
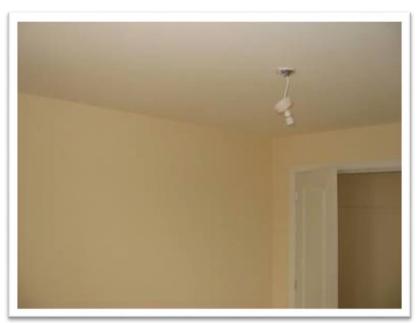
The internal and external appearance gave nothing to suggest otherwise...

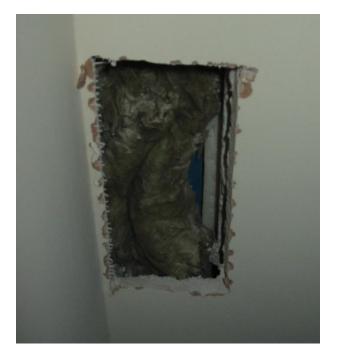
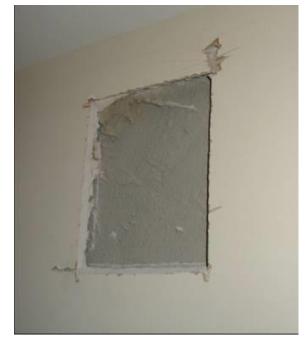
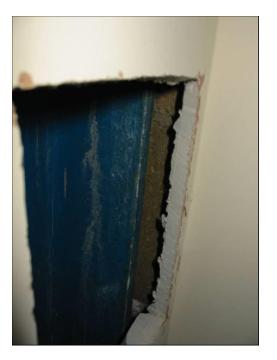
...the ground floor had been constructed in steel frame, with cavity masonry separating walls between columns.

The steel frame supported an insitu concrete first floor structure, on top of which was timber frame construction...

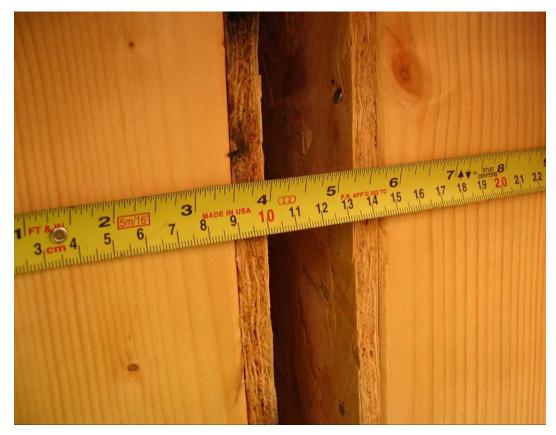
Timber walls

The importance of correct setting out and maintaining the gap between the faces of sheathing.

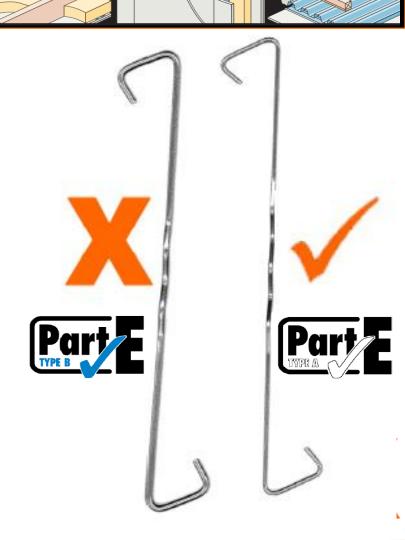
Correct masonry wall ties

Separating walls – Type A Flanking walls – Type A or B

- note cavity width
- tie spacing

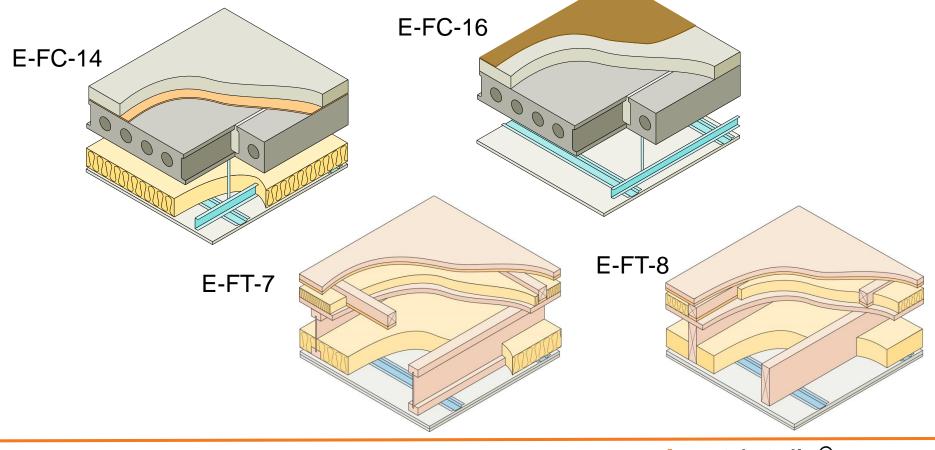
Efforts have also been made to provide new floors aimed at achieving higher sound insulation performance, for example...
